**DRAFT ROUND 10 DAM ASSESSMENT REPORT  
NIPSCO DH MITCHELL GENERATING STATION  
COAL ASH IMPOUNDMENTS**

**NOVEMBER 11, 2011**

Re: Round 10 Dam Assessment - Draft Report  
EPA Contract No. EP10W001313  
NIPSCO – DH Mitchell Generating Station  
Coal Ash Impoundments  
Gary, Indiana

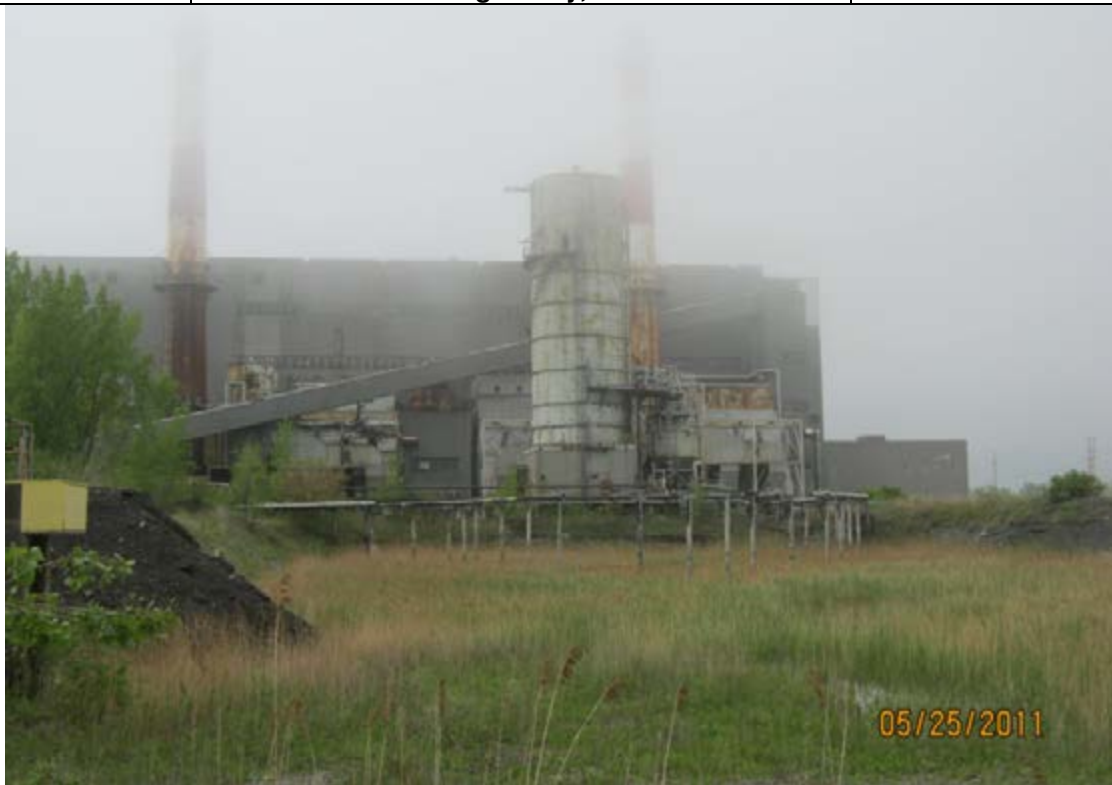
**Description:**  
Primary Settling Basin No. 1  
with the DHMGS in the  
background.

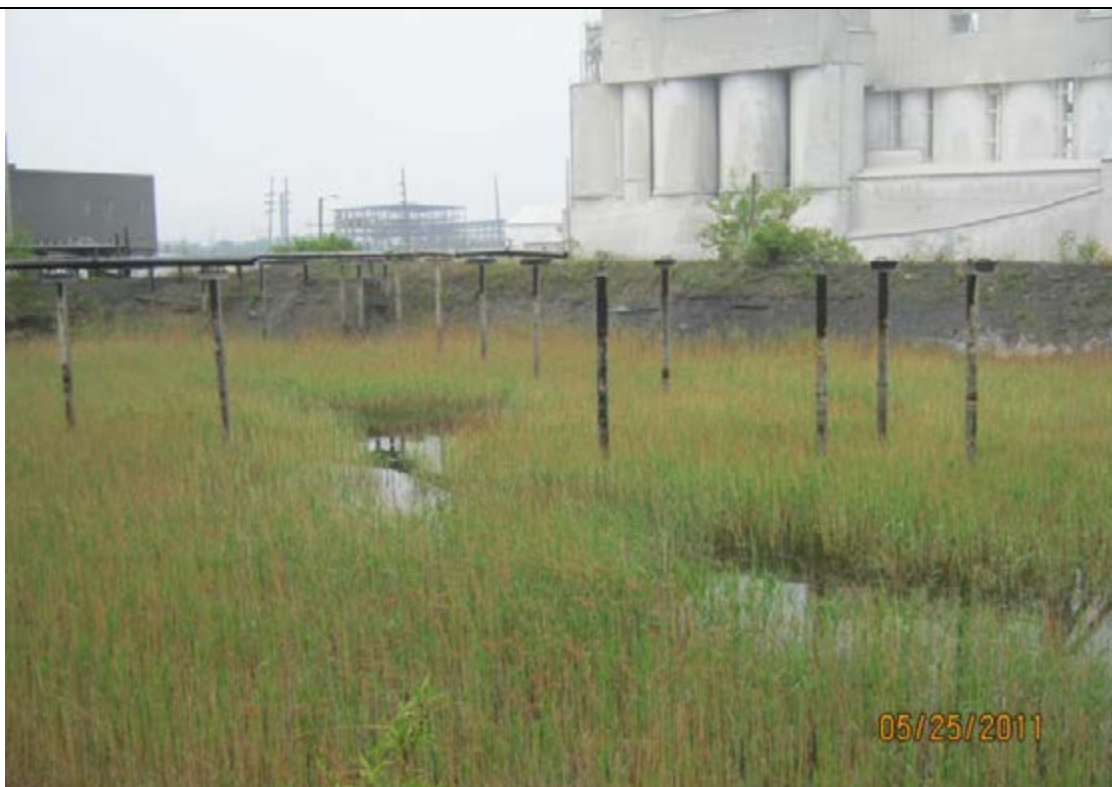
**Photo No.**  
**2**

**Description:**  
Primary Settling Basin  
No. 1.
